**Flood Control Project Maintenance
Levee Inspections**
LMA District Cover Sheet
Spring 2013 Levee Inspection Results

Reclamation District No. 2060 Hastings

Levee Inspection Report By Mile - Spring 2013

Waterway				Bank	Unit Miles	Inspection Start/End	Inspector
Unit No. 01 Lindsey Slough				Left	6.94	03/28/2013 03/28/2013	Herman Phillips

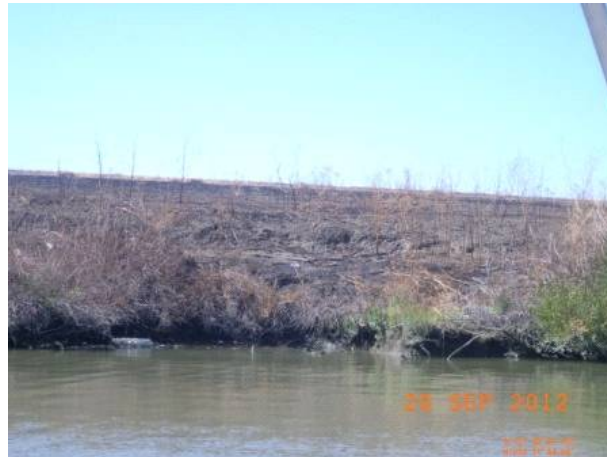
USACE 2012 Photo #1

4	2.18	2.23	Supplemental	USACE Erosion Survey	WS Ma	Inspector Comments: 2007 - Geotechnical failure of midside slope and wave wash/scalloping in toe area. Stone revetment upstream and downstream of site. Similar sites are present all along the right bank downstream of this site, most could be repaired with some maintenance. 2010 - Minor new erosion. 2012: No observed change. [2012 Site ID: CHS_22-8_R]	38.282100 ° -121.716817 °	38.281510 ° -121.716319 °	6 Y
DWR ID: DWR_RD2060_03_s_2013_6									
5	2.38	2.54	Supplemental	USACE Erosion Survey	WS Ma	Inspector Comments: 2008 - Small scour pockets and mid-slope wave wash. 2010 - More vegetation growth, could be fixed through maintenance. 2011 - Site extended downstream and new erosion. 2012: No observed change. [2012 Site ID: CHS_22-6_R]	38.280377 ° -121.714633 °	38.278306 ° -121.712722 °	8 Y
DWR ID: DWR_RD2060_03_s_2013_8									
6	2.79	3.25		Vegetation	WSA/W Ob	V8 : Environmental Requirements.	38.280919 ° -121.715756 °	38.275177 ° -121.709777 °	3
